**Docket No. 217 – Development and Management Plan Inspection**

**Date:** January 19, 2006

**Inspector:** Diana Walden

**Location:** 345kV Underground Route

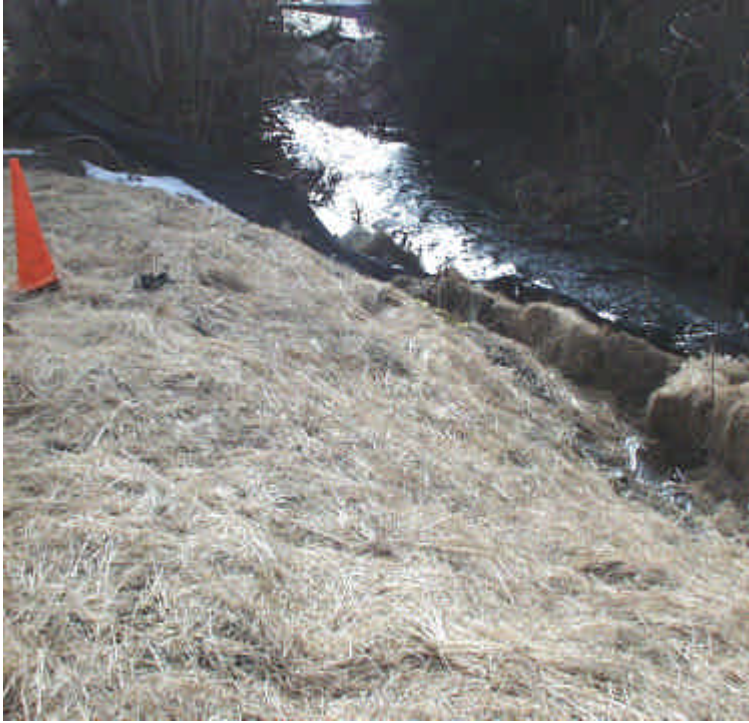
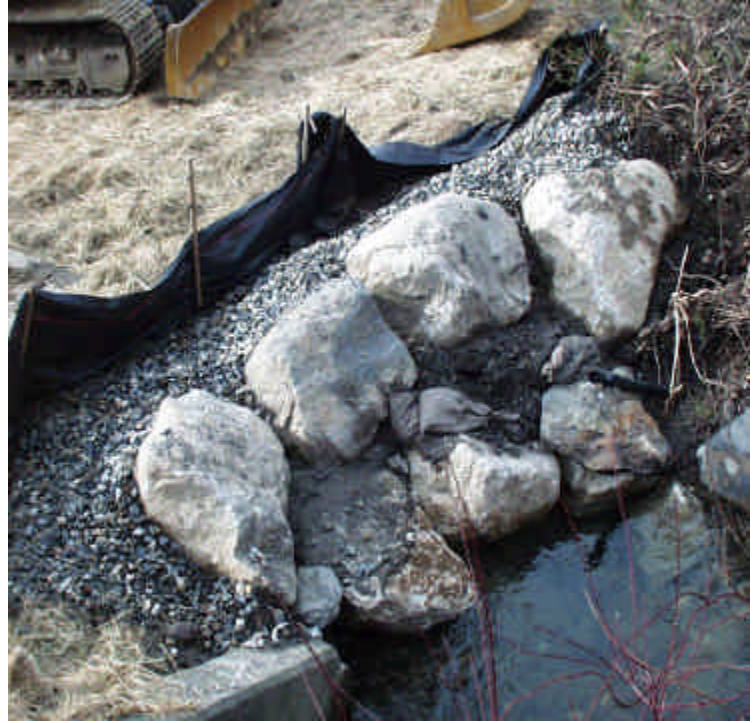
**345kV (Georgetown Deli Jack and Bore):** Photo on the left shows the backfilled and restored slope on the bore pit side. Photo on the right shows the receiving pit side where the streambank was restored with boulders, similar to what was previously present. 1/19/06

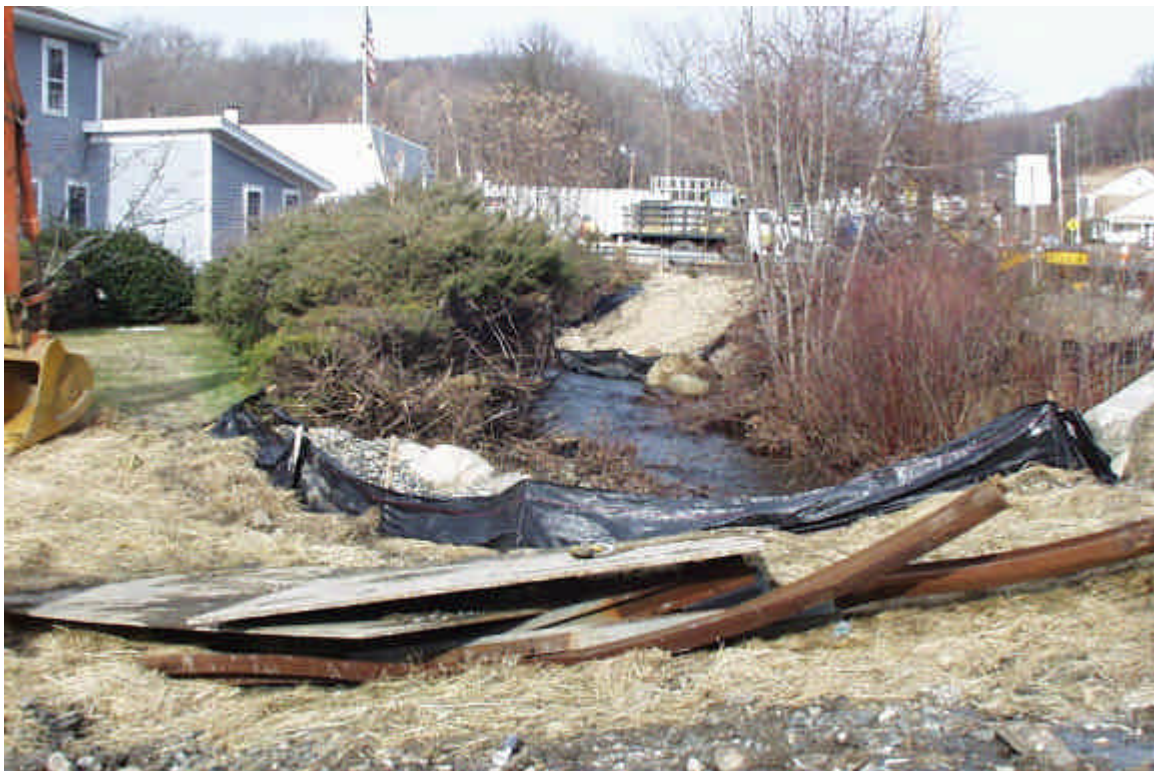
Photo on the left shows the overview of the restored area around the Georgetown Deli now that the jack and bore is complete. Dewatering has ceased and tanks are being demobilized. Good restoration measures were placed. 1/19/06

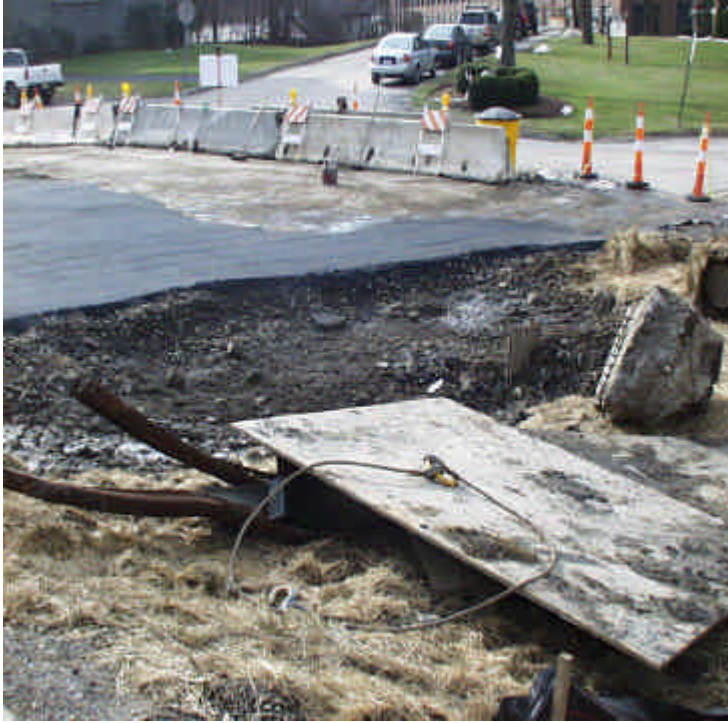
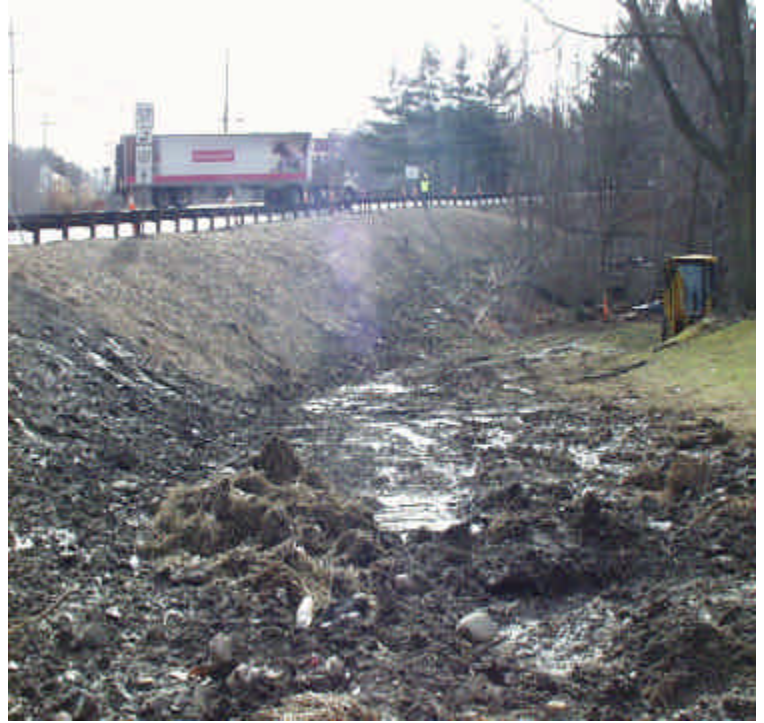
**345kV (Rt. 107 work) Photo on the left shows the restoration of the driveway adjacent to the receiving pit work. Photo on the right shows the slope above the Norwalk River which had been well restored. The area below could use some restoration as well. 1/19/06**

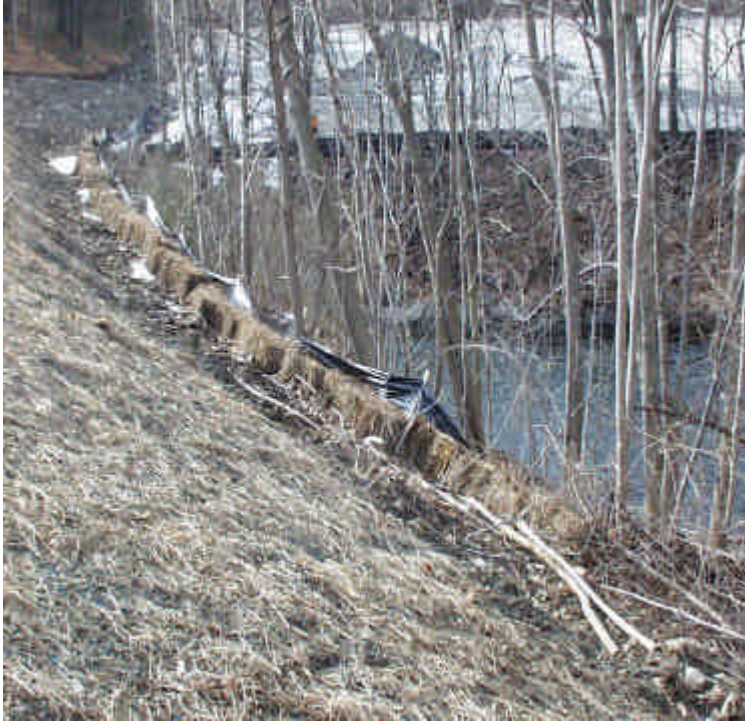
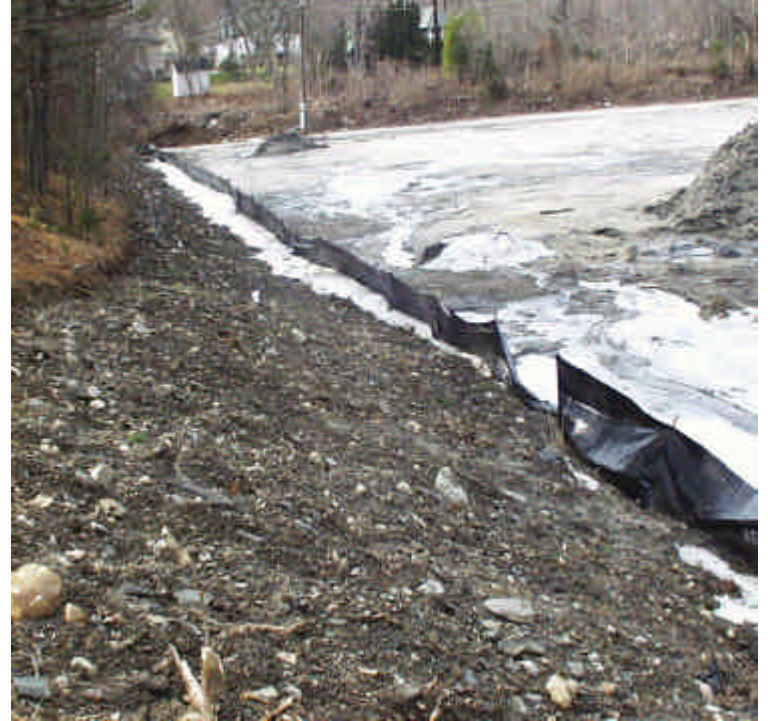
**Photo on the left shows a close up of the slope and the erosion controls left in place above the river. This work was completed without incident. Photo on the right shows the silt fence in place along the redevelopment property to keep sediment off the site. One section of silt fence needs repair. 1/19/06**

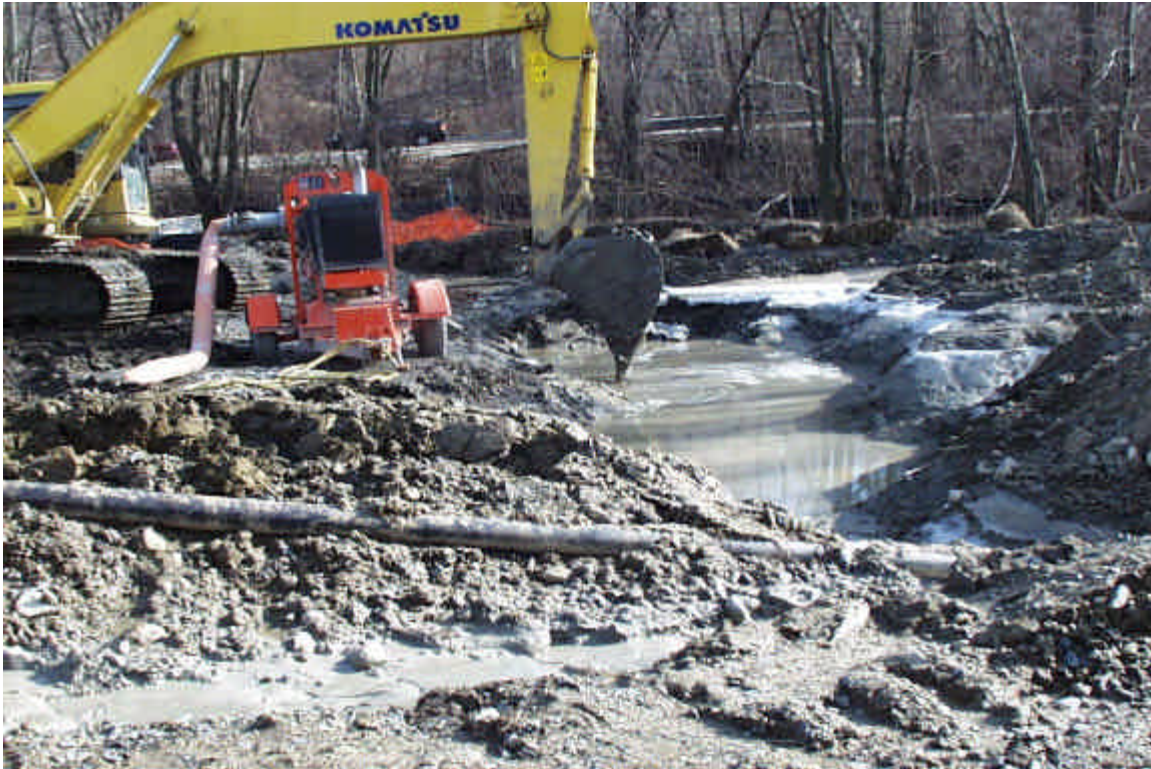
345kV (HDD): View of the basin where muds were being actively pumped from the length of the bore. The water was being pumped from the basin and returned to the tanks for re-use. 1/19/06

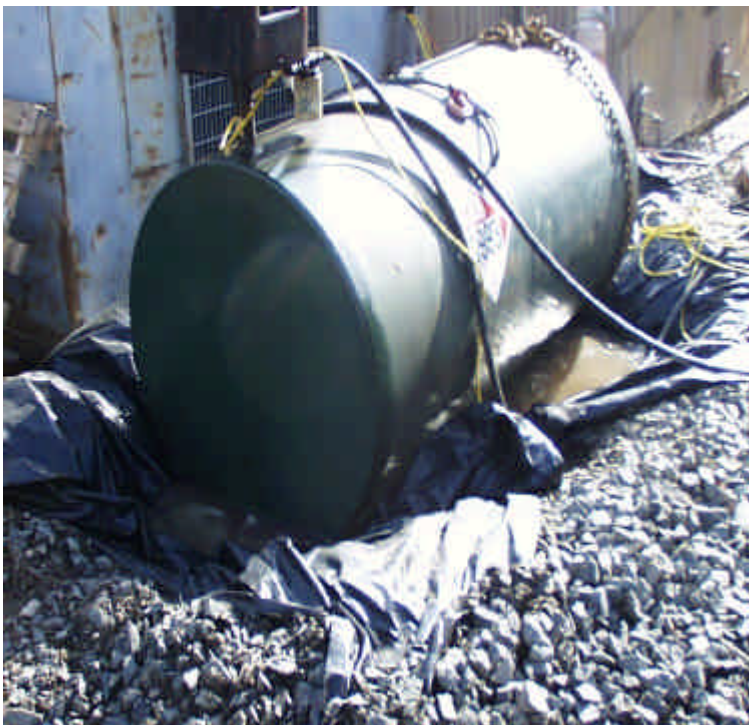
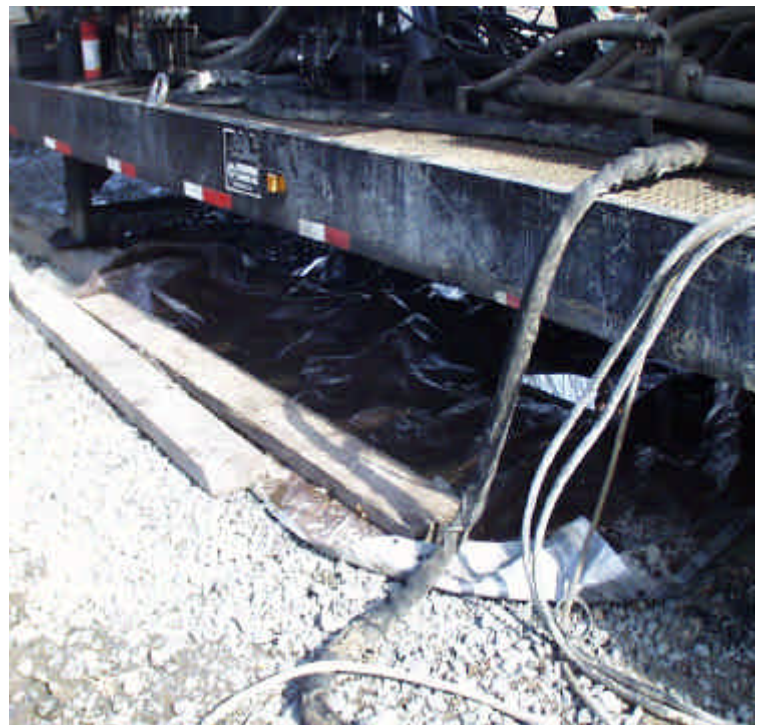
Photo on the left shows where plastic was installed under the fuel tank to collect any drips or spills. The photo on the right shows plastic installed under equipment to contain a leak that was noted. 1/19/06

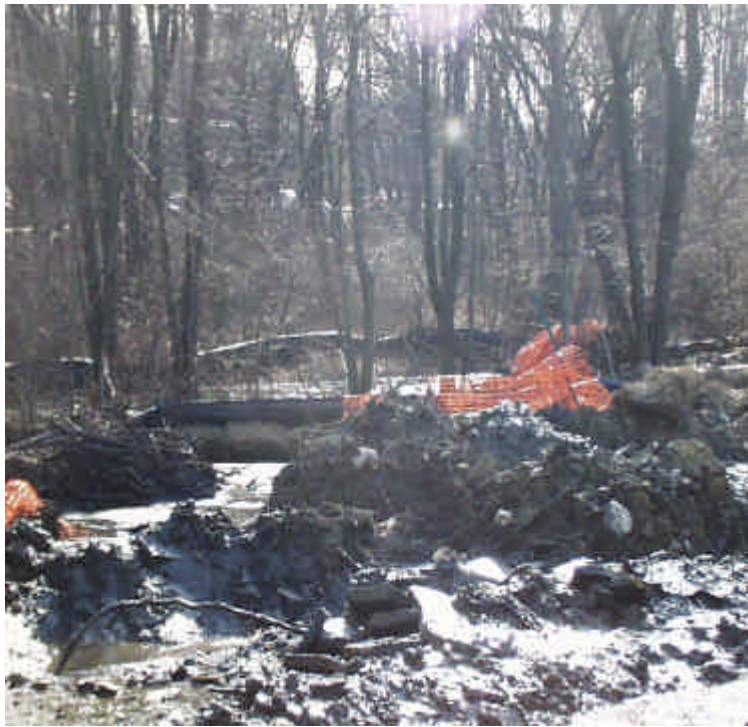
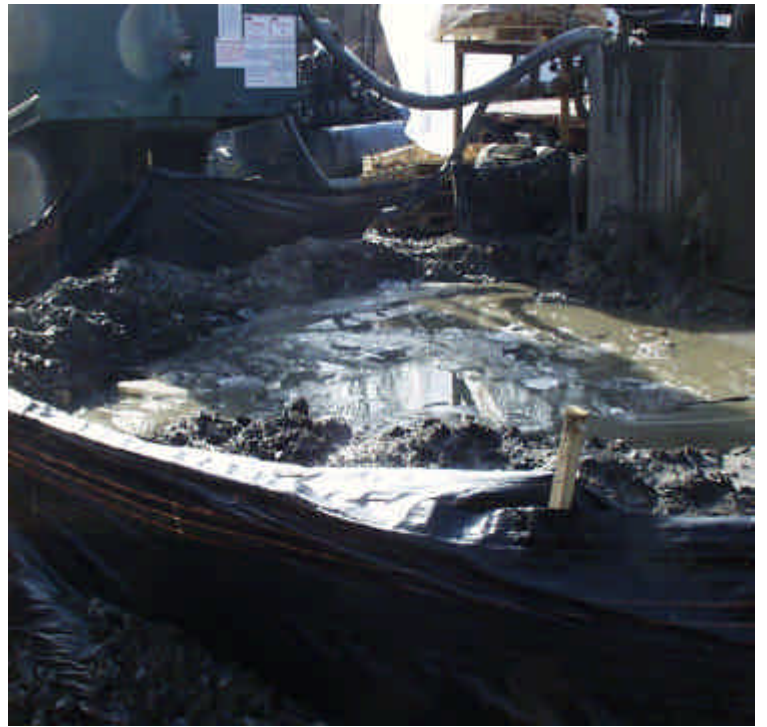
Photo on the left shows the additional haybales and controls installed to the east of the basin. Photo on the right shows the silt fence reinstalled around the baker tank to control turbid water associated with the drill cuttings. 1/19/06

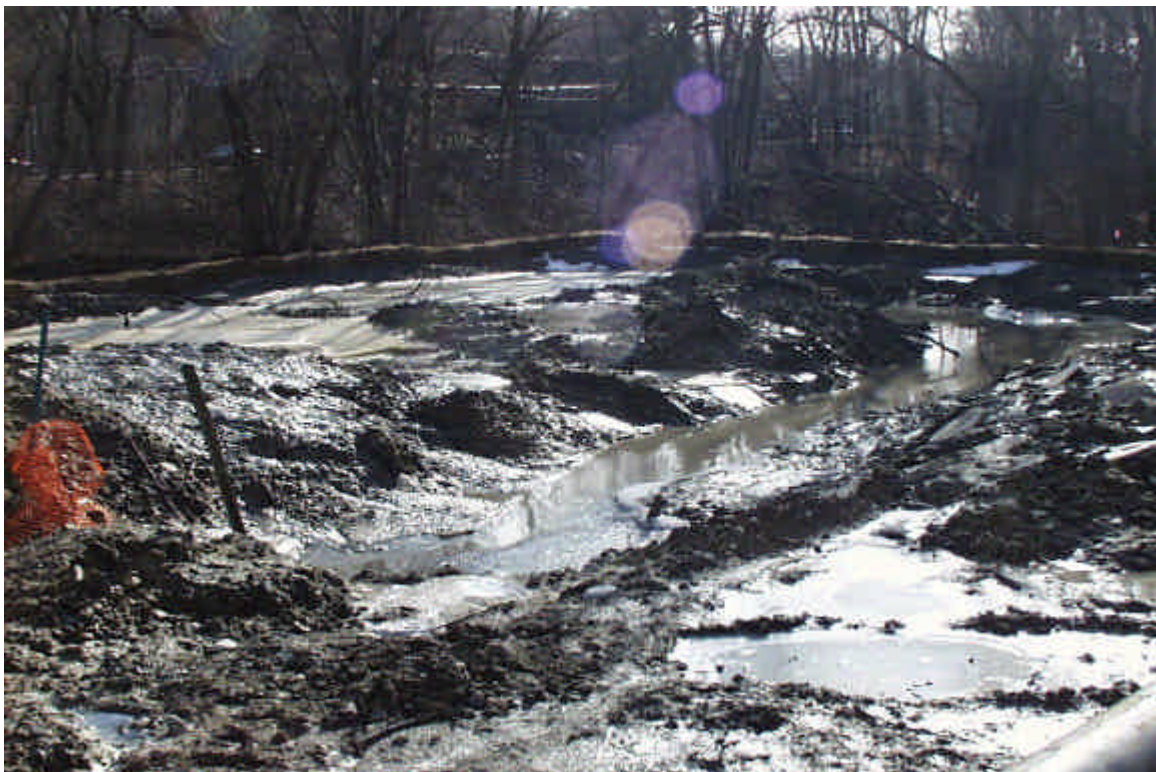
Overview of the basin and yard. Good controls were installed but the area is still highly disturbed. 1/19/06

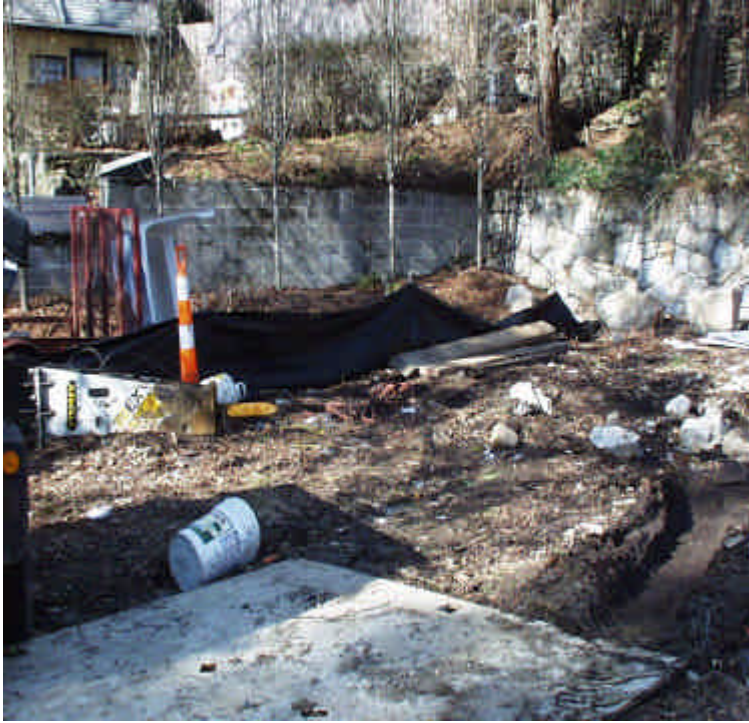
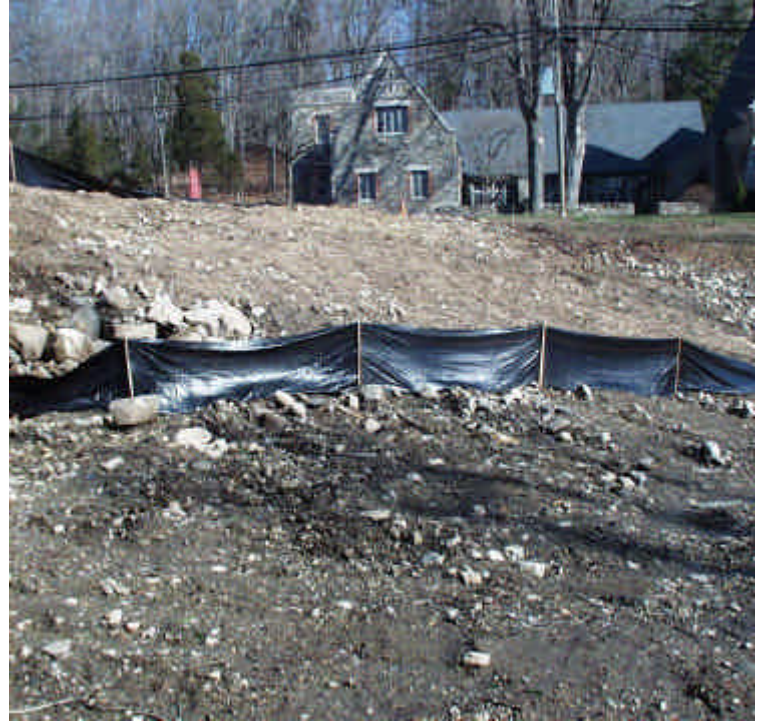
**345kV (Rt. 7):** Photo on the left shows a small storage area across from Old Highway Rd. Some general housekeeping was needed here. Photo on the right shows silt fence installed down the slope with mulch placed on the slope above the storage area. 1/19/06

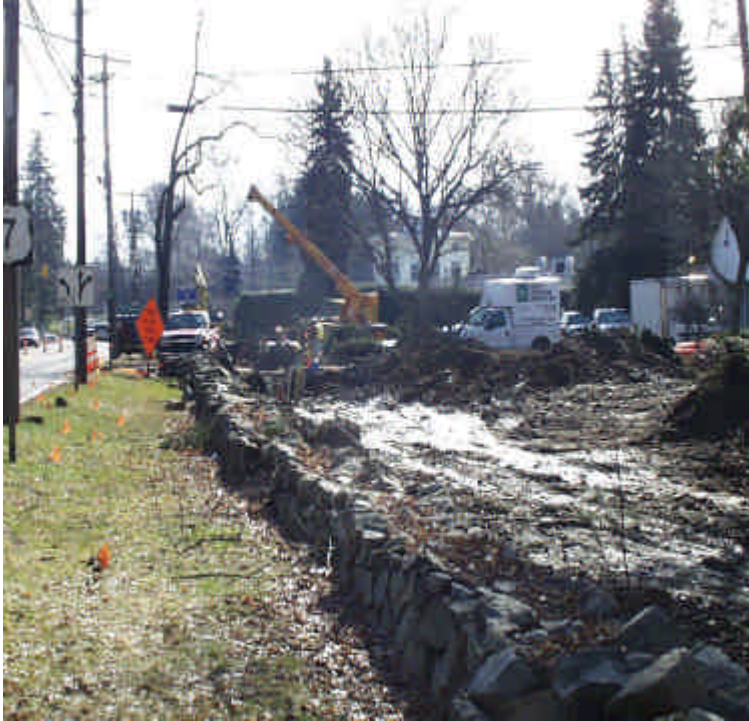
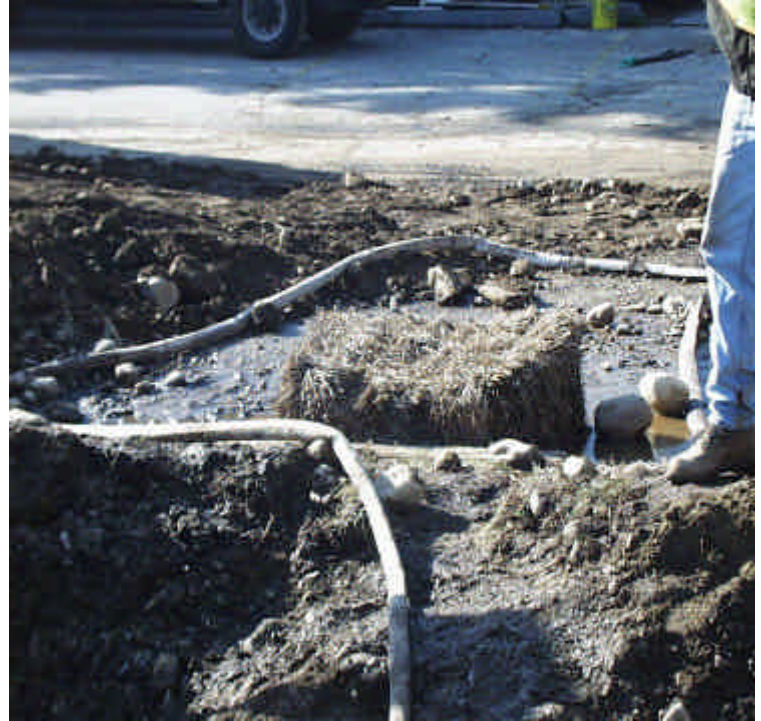
Photo on the left shows the work area along Rt. 7, just off the roadway in the vicinity of Cricket Lane. Active trenching was ongoing here. Photo on the right shows attempts to protect catch basins in the area. 1/19/06
